# Appliqués for Corrosion Protection in a Tropical Environment

GUY D. DAVIS, *DACCO SCI, Inc., Columbia, Maryland*  
TERRY VARGO, *Integument Technologies, Tonawanda, New York*  
DOUGLAS DEASON, *U.S. Army Space & Missile Defense Command/ARSTRAT, Huntsville, Alabama*

*Appliqués were placed on several structures at the Pacific Missile Range Facility in Kauai, Hawaii. They were periodically inspected and compared to the original paint coatings. The appliqués provided excellent corrosion protection. In some cases, the original paint did not provide adequate protection, requiring either repainting or replacement of the structure.*

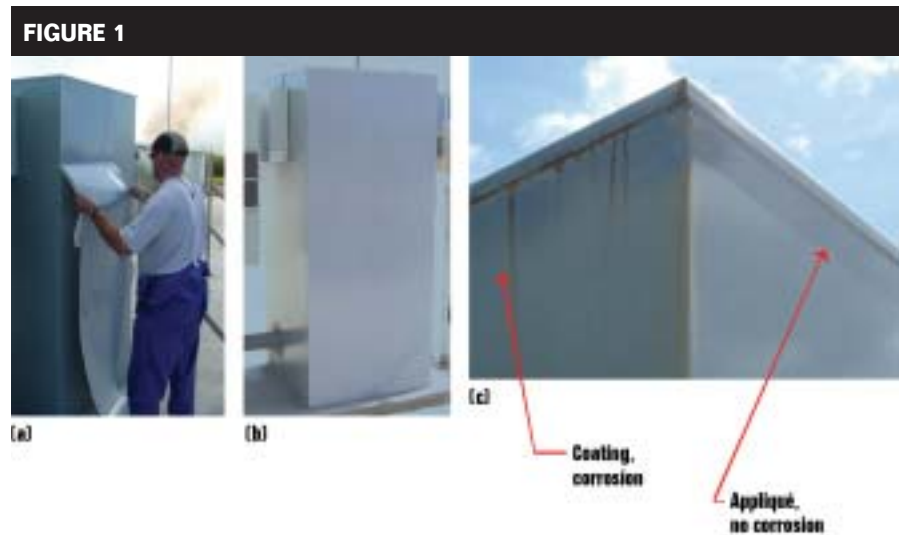
Equipment cabinet at launch site. After approximately six months, corrosion had occurred along the edges of the metal sheet. (a) September 2004, applying appliqué, (b) after application, and (c) March 2005.

appliqué (Figure 1). By the time of the first inspection at six months, corrosion on the exposed edges of the roof panel and blistering of the OEM's paint were readily visible, as were rust stains down the sides of the cabinet. An attempt to ameliorate this rust had been made at one point by painting over the rust stains. No corrosion, blistering, or other deterioration were observed where the appliqué had been applied. By April 2005 (approximately seven months after installation), the corrosion was sufficient that a decision was made to replace the original cabinets with stainless steel (SS) cabinets covered by a SS enclosure.

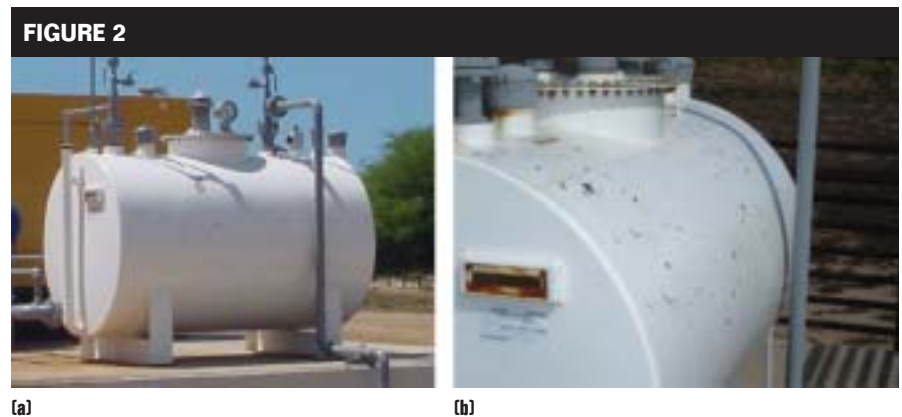
East side (mountain side) of storage tank at block house without appliqué. The tank was dirty with bird droppings and rust spots until recoating. (a) September 2004—without appliqué, and (b) October 2005.

The west side (toward the ocean) of a white fuel tank was covered by a white 3-mil polyvinylidene fluoride appliqué; the east side (toward the mountain) was left as received (Figures 2 and 3). The east side quickly became dirty from bird droppings and rust spots where the paint had failed (Figure 2). Because of its appearance and deterioration, the entire tank was cleaned and repainted between the 20th and 25th months. Small spots of corrosion were already beginning to form on the repainted areas. In contrast, the west side with the appliqué remained clean the entire time (Figure 3). Although this side likely received fewer bird droppings than the east side, the non-stick appliqué surface allowed rain to wash

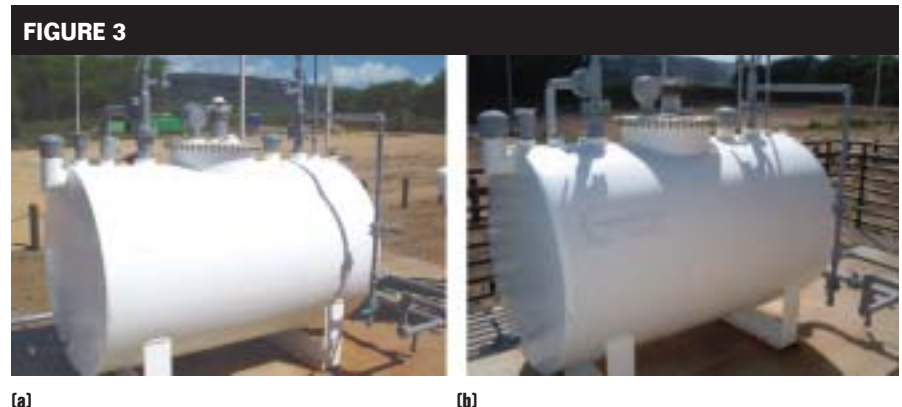
West side (ocean side) of storage tank at block house with appliqué. (a) September 2004—appliqué as installed, and (b) October 2005.

the droppings away to maintain a clean surface.

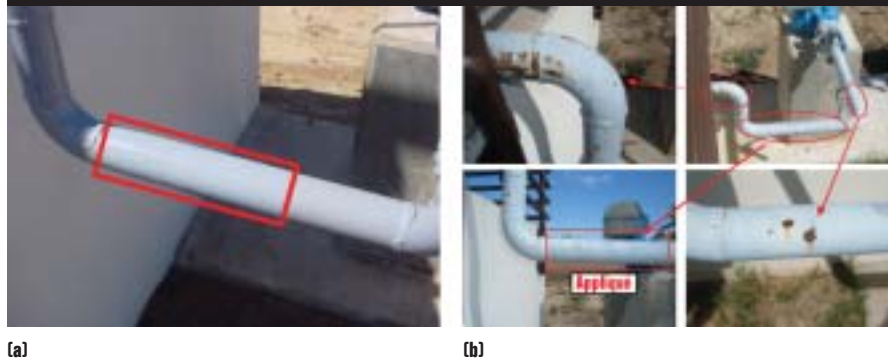
FIGURE 4

Piping to fuel tank at blockhouse. The red rectangles indicate the approximate location of the appliqué. (a) September 2004—as installed, and (b) October 2005.

Sections of the piping to the fuel tank were covered with a 3-mil gray ECTFE appliqué at the same time as the tank (Figure 4). Before the initial inspection at six months, mechanical damage had occurred in some areas of the paint and the appliqué. Corrosion was readily visible in the damaged painted areas as well as some painted areas that were not damaged. This corrosion continued and worsened until the entire piping was repainted between the 20th and 25th months. At no time was there any corrosion on the appliqué areas, whether they were damaged or not.

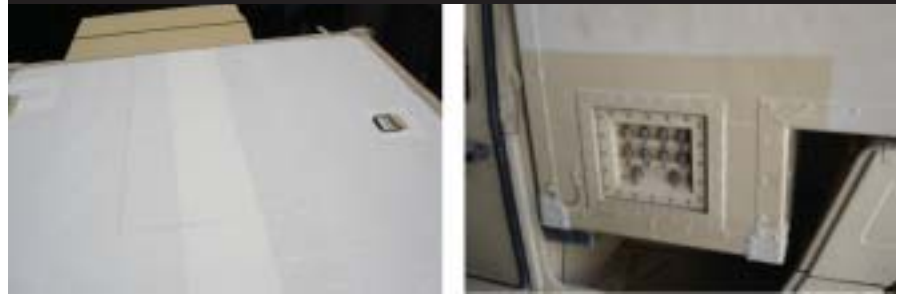
**FIGURE 5**

Aside from the color change or darkening, which could be prevented by matching the appliqué color to the CARC tan, the only issue needing to be addressed was coverage of complex shapes. Covering the rivets and raised areas of the HMMWV near the edges of the appliqué allowed a few places where moisture could ingress and remain. This

caused corrosion in some places, but it must be emphasized that these areas were a small fraction of the appliqué area and could be reduced or eliminated with optimum appliqué application.

Electronics unit after application of appliqué. (a) roof, and (b) October 2005—appliqué covering rivets.

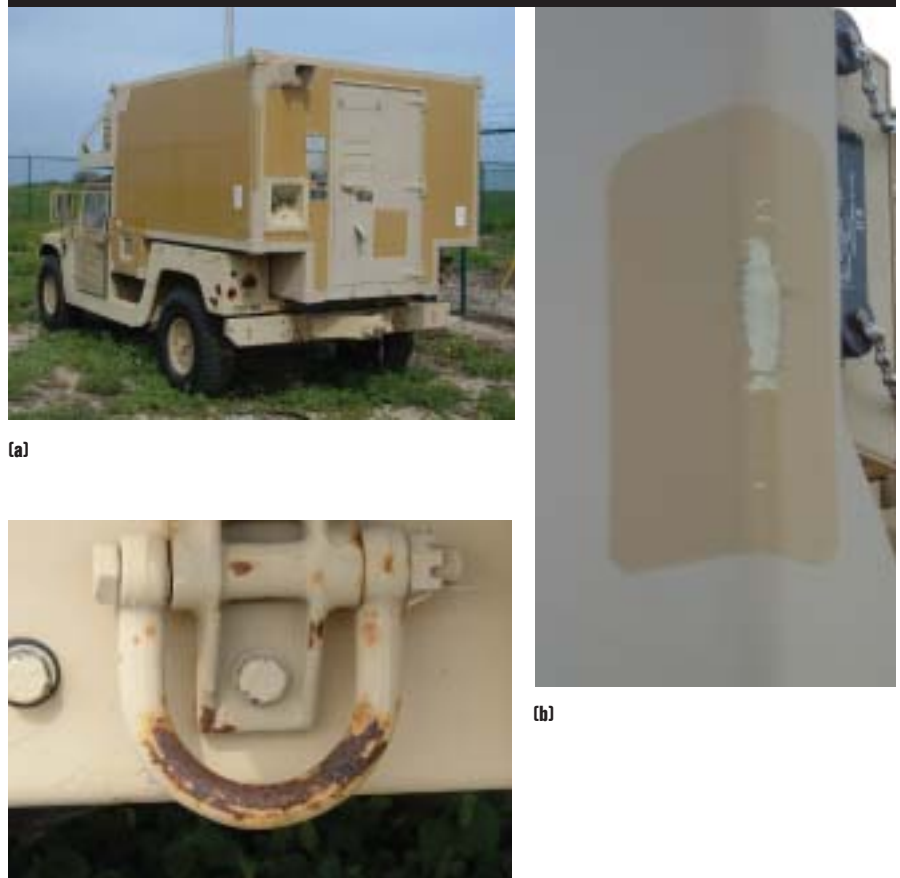
**FIGURE 6**

The HMMWV was inspected at PMRF on October 2005, May 2006, and October 2006. Paint repair by appliqué showed excellent performance. Figure 6 shows a repaired patch with no corrosion seen on the bare metal under the appliqué. Similarly, no corrosion was observed on a scribed appliqué patch. For comparison, a tie-down loop from which the paint had been removed is shown to demonstrate the amount of corrosion expected on bare metal.

HMMWV after approximately one-year exposure at PMRF. (a) overview, (b) coating repair, and (c) corrosion on bare metal.
