## Smart Appliqués for Corrosion Protection and Health Monitoring

### ABSTRACT

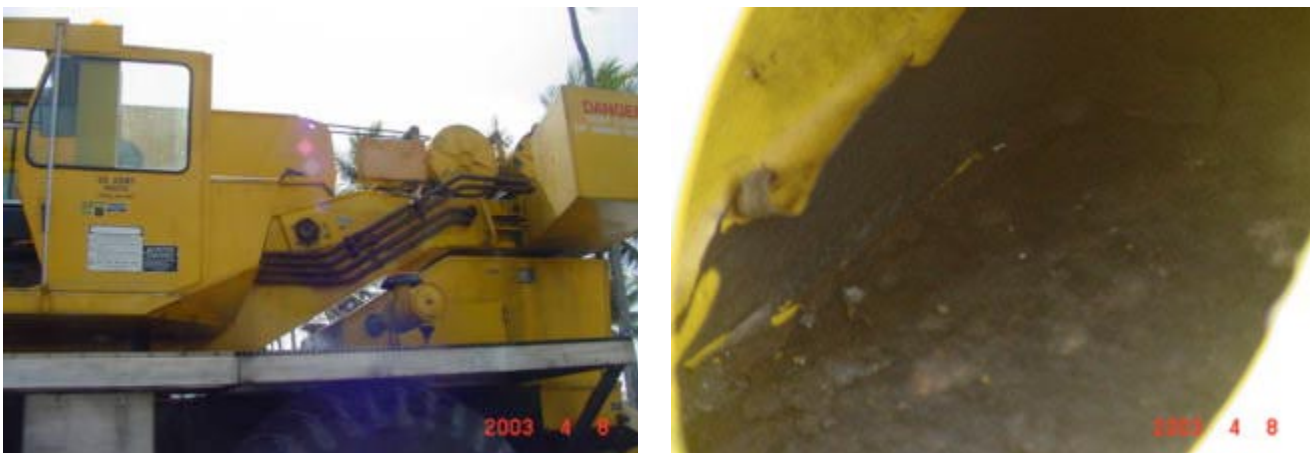
Figure 2. Left: Boom truck on Kwajalein Atoll. Right: Close up of corrosion that made boom truck unsafe and inoperative after only 3 years.

The corrosiveness of the tropical Pacific environment is illustrated in Figure 2. Corrosion made a half-million-dollar boom truck unsafe and useless at Kwajalein Atoll after only 3 years. The constant salt

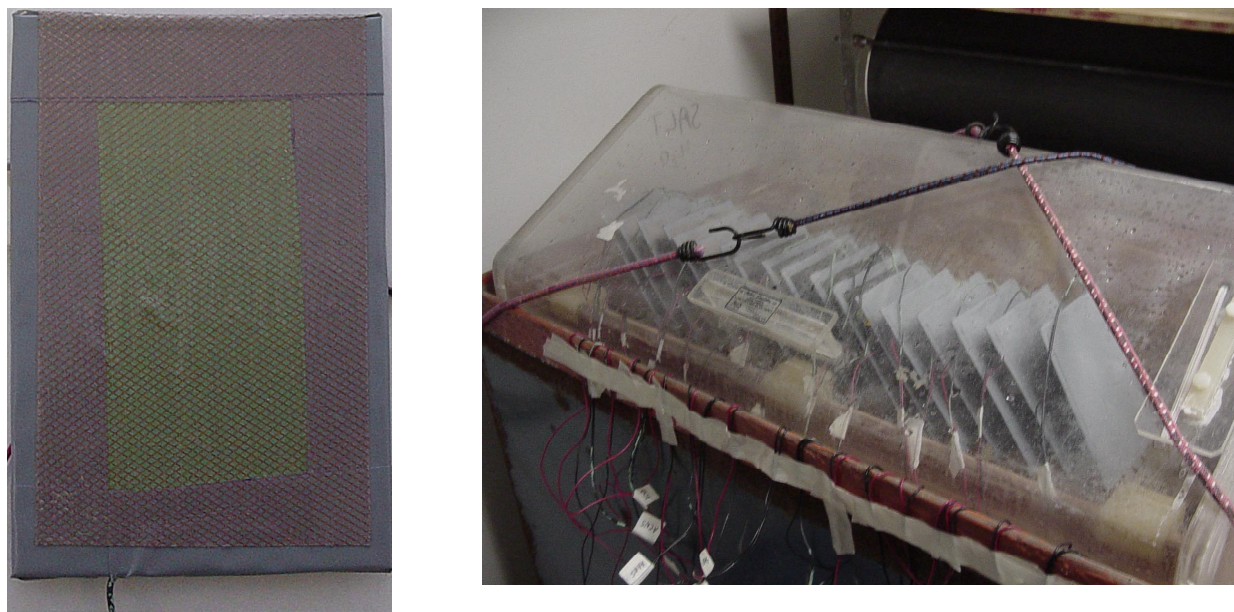
Figure 5. Left) Representative specimen with clear appliqué showing sensor electrode underneath. Right) Specimens in salt fog.

One set of specimens consisted of intact appliqués, such as those in a field application. These specimens were not expected to corrode in 2000 hours of salt fog and did not. Other specimens had deliberate defects intended to allow corrosion in this period. In one set, the front appliqué (with sensor) was scribed to the metal. In the other set, a hole was drilled from the backside to allow salt and moisture ingress below the intact front appliqué. Photographs of a specimen with a clear appliqué to show the mesh sensor electrode underneath and of the specimens in the salt fog chamber are given in Figure 5.

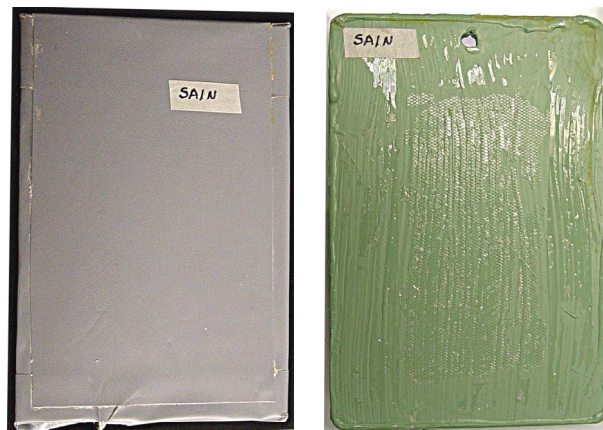
Figure 6. Example of no-defect steel specimens before and after appliqué removal.

No corrosion is seen in the no-defect specimens following 2000 hours of salt fog exposure. For two of them, the appliqué was removed to check underneath; no corrosion was observed (Figure 6). Small amounts of corrosion were seen at some of the back holes, but not in others. Moisture ingress via the hole was also detected in some specimens between the appliqué and primer. Rust streaks were observed from the scribed steel specimens; minimal corrosion was seen on the scribed aluminum specimens with the exception of the Cu electrode/no corrosion inhibitor specimen discussed below.

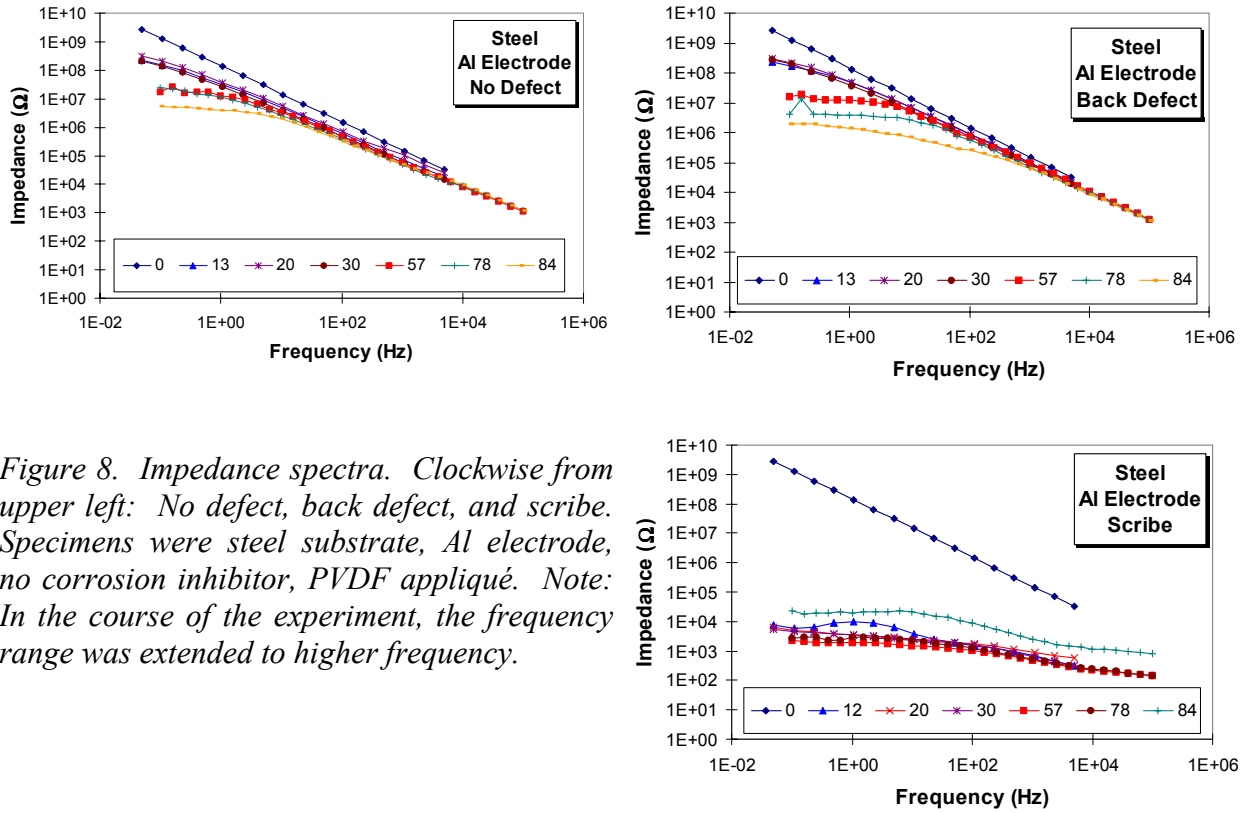
Figure 8. Impedance spectra. Clockwise from upper left: No defect, back defect, and scribe. Specimens were steel substrate, Al electrode, no corrosion inhibitor, PVDF appliqué. Note: In the course of the experiment, the frequency range was extended to higher frequency.

Typical impedance spectra for the no-defect, back-defect, and scribed specimens are given in Figure 8. Initially, the low frequency impedance in each case is approximately  $10^9 \Omega$ , which is excellent for a primer. Upon exposure to the salt fog environment, the impedance of the scribed specimen drops immediately by several orders of magnitude reflecting the breach in the appliqué and primer and ingress of

moisture to the substrate. Thus the sensors have a very clear indication of appliqué defect as might be caused by a gouge or other mechanical damage. The other two specimens with the intact sensing appliqué only slowly decrease in impedance with time with the back defect specimen showing a slightly greater decrease. The relative decreases in low frequency impedance for the different conditions are best illustrated by average over all examples of a given defect. The low frequency impedance is given as a function of time in Figure 9. The no defect specimens show a gradual decrease in the impedance over time from  $10^9 \Omega$  to  $\sim 10^7 \Omega$ ; in contrast the scribed specimen shows an immediate drop in impedance to  $10^3$ - $10^4 \Omega$  as moisture reaches the substrate. It should be noted that no visible signs of corrosion were apparent at this time.
