In-Situ Sensor to Detect Moisture Intrusion and Degradation of Coatings, Composites, and Adhesive Bonds

G.D. Davis, C.M. Dacres, and L.A. Krebs

DACCO SCI, INC.
10260 Old Columbia Road
Columbia, MD, 21046
davis@daccosci.com
www.daccosci.com

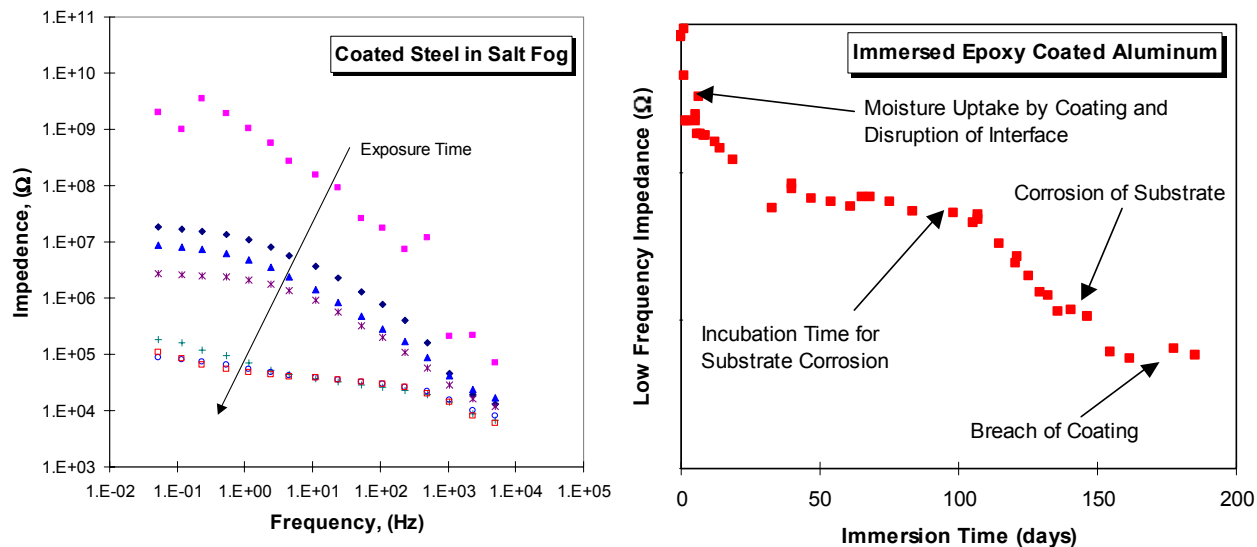
Figure 1. Left: Typical impedance spectra of a coating during degradation. Right: Low-frequency impedance as a function of exposure time showing three stages of degradation: moisture absorption, incubation, and substrate corrosion.

Electrochemical Impedance Spectroscopy (EIS) has long been used to evaluate coatings and study corrosion in the laboratory.¹⁻⁷ Correlations have been made with EIS parameters, such as low-frequency impedance and breakpoint frequency, and performance under different conditions. Initially, a coating exhibits capacitive behavior with very high impedance at low frequency. As the coating absorbs moisture, the low-frequency impedance decreases and becomes independent of frequency (Figure 1). The low-frequency impedance is a sensitive measure of coating and substrate health; it decreases by several orders of magnitude as moisture is absorbed and substrate corrosion occurs. This change occurs well before any visual indication of deterioration.

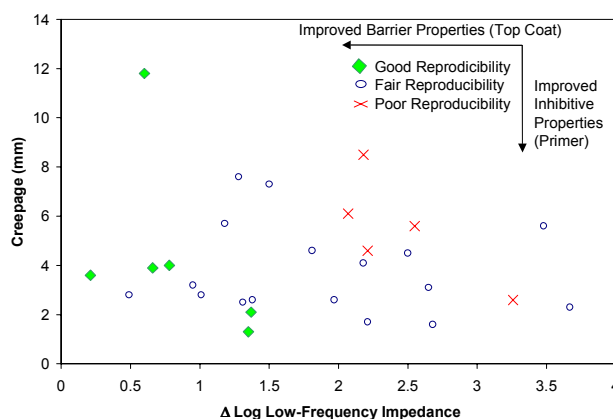
Figure 6. Creepage from a scribe as a function of the difference in log low-frequency impedance caused by a cyclic accelerated test for several top coat/primer systems. The best coatings would be near the origin. Also shown is a measure of the reproducibility from run-to-run and specimen-to-specimen. The best performing coatings have the best reproducibility.

Several topcoat/primer systems were evaluated using another cyclic exposure test (Figure 6). The sensor measurements, which were taken periodically during the exposure, reflect the stability and water resistance of the topcoat. The panels were scribed and creepage or corrosion from the scribe was also measured. The creepage reflects the adhesion and inhibitive capability of the primer. The two parameters are correlated in Figure 6. In this figure, the best coatings would be near the origin – they would exhibit little moisture absorption and little corrosion at the scribe. The data clearly show that the two parameters are only partially related and that the primer and topcoat properties can be independently varied. Several coating systems showed significant water absorption but little spread of corrosion from the scribe. One showed significant corrosion at the scribe although the topcoat was very moisture resistant. Interestingly, the best coatings exhibited the best reproducibility from measurement-to-measurement and from specimen-to-specimen. The poorer coatings were more likely to have significant specimen-to-specimen variation or even changes in a single specimen over the course of taking duplicate measurements.

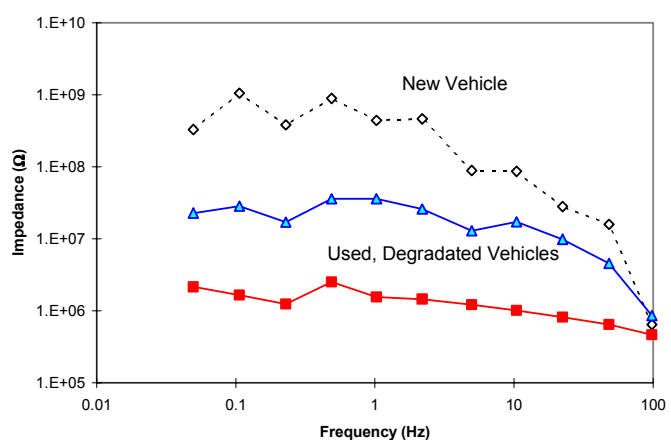
Figure 8. Impedance spectra from new and corroded land vehicles.

The second example involves three land vehicles. One vehicle had been stored inside for several years and was in very good condition. The other two vehicles had been extensively used in a corrosive environment. Sensor measurements were taken in several areas on each vehicle. Although the later two vehicles had considerable rust, care was taken to acquire impedance spectra away from the rust in areas where the coating system looked good. The data of Figure 8 clearly show a difference between the coatings on the new and used vehicles with the impedance decreasing by two-three orders of magnitude although there were no visual differences in the areas inspected. The measured low-frequency impedance of the two used vehicles seemed to correlate with the general visual appearance – the one with the lowest impedance had the greatest rust over its body.

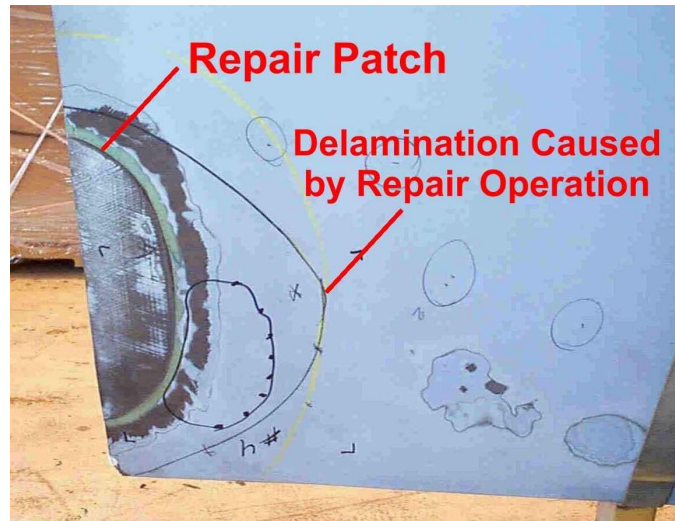
Figure 10. F/A-18 trailing edge flap following repair showing additional moisture-induced delamination during the repair operation.

Moisture in the composite, in the adhesive between the composite and the core, or in the core itself can cause significant damage during repair when the moisture turns to steam and internal pressure can exceed bond strengths. The repair failures are more pronounced with the use of 350°F-curing adhesives and have led to change orders authorizing the use of 250°F-curing adhesives during Depot level composite repairs.²⁴ Figure 10 shows an example of such repair-induced damage. During the curing of the repair patch on the left, additional delamination, marked by the black line surrounding the patch, occurred as residual moisture turned into steam.

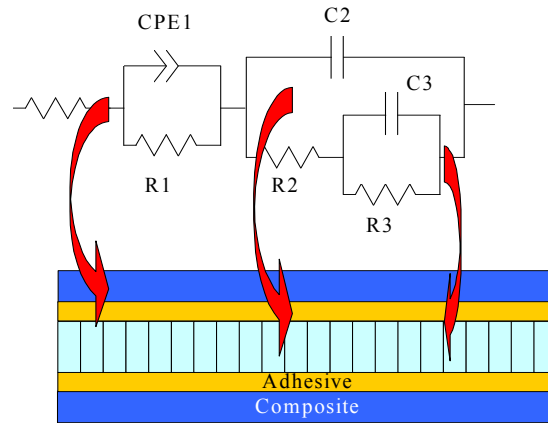
Figure 16. Equivalent Circuit Models the AS4/3501-6, FM300, Al core honeycomb composite. The circuit should be able to model similarly constructed materials by varying the values of the individual circuit elements.

For aluminum core honeycomb composite specimens, equivalent-circuit analysis was needed. The model of Figure 16 consists of two loops in series and a third imbedded loop. The R1/CPE1 parallel combination is a collapsed version of the monolithic composite circuit and is included to account for moisture absorption in the skin. The R2/C2 parallel combination with the imbedded R3/C3 parallel loop is based on a standard circuit model often used for the analysis of coated metals. In this case, R2/C2 represents moisture absorption in the adhesive joining the core and the skin. The R3/C3 portion represents activity at the adhesive/core interface. A final resistor is again placed in series with the circuit to represent any small “solution” resistance.

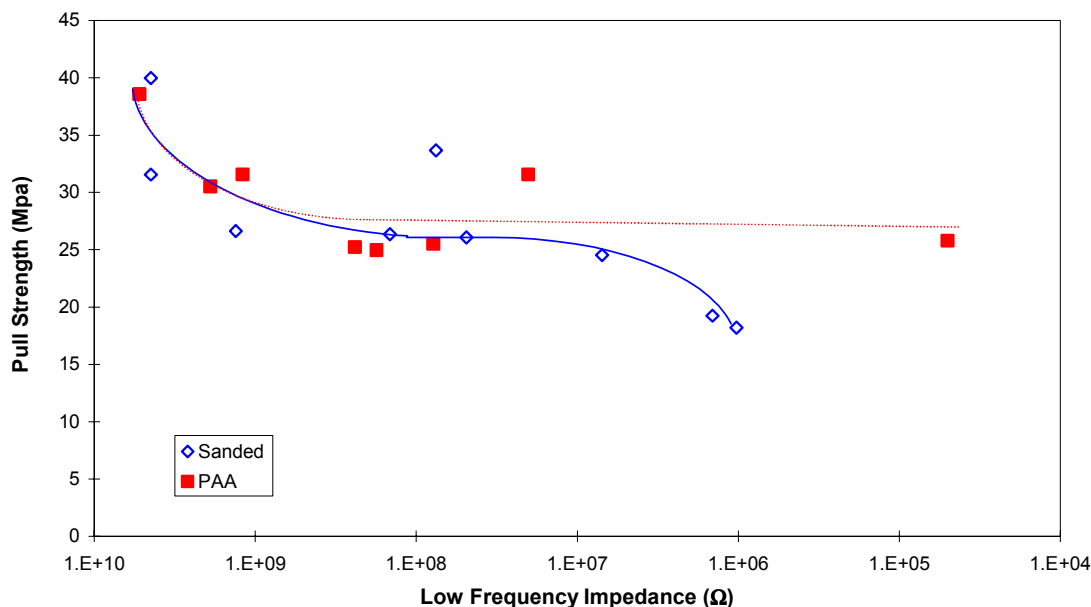
Figure 19. Tensile pull strengths as a function of low-frequency impedance for PAA and sanded aluminum surfaces.

The effect of this moisture absorption on the tensile pull strength strongly depends on the surface treatment. This dependence is illustrated in Figure 19. The initial decrease in pull strengths from approximately 38 MPa to 27 MPa corresponds to a decrease in the cohesive strength of the adhesive as moisture is absorbed. For PAA specimens, the length of time available for this experiment (approximately five months) under these conditions (humidity, followed by immersion) was insufficient to induce hydration. Accordingly, the microcomposite interphase formed by the porous PAA oxide²⁸ and the adhesive remained stable and stronger than the cohesive strength of the adhesive so that failure was almost entirely within the adhesive. Similar behavior was also observed for grit blasted and FPL-etched specimens, with the exception of an FPL surface at the end of the experiment where the strength decreased by approximately 50% and partial interfacial failure occurred as the result of hydration. In contrast, because the sanded surfaces exhibit no evolved microroughness, their bonds to the epoxy adhesive rely more on secondary bonds, such as van der Waals forces, which are readily disrupted by moisture. The locus of failure in this case gradually shifted to increasingly more interfacial with the interfacial region beginning along one segment of the edge and growing along the circumference and toward the center.

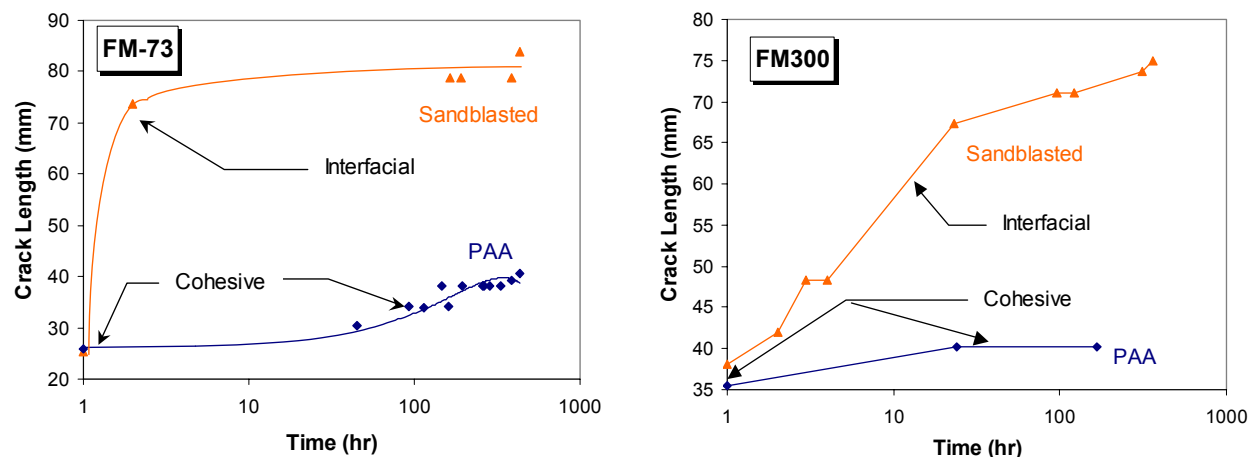
Figure 21. Wedge test crack growth for PAA and sandblasted specimens. Left: FM-73. Right: FM-300

The response of the bondline to this absorbed moisture is governed by the type of interfacial bonds and the stability of the interface (Figure 20 and Figure 21). For sandblasted specimens, for which the crack propagates interfacially, the initial, rapid crack growth occurs with minimal change in the low-frequency impedance. For these weak interfaces, which rely predominately on secondary forces that are easily disrupted by moisture,²⁵⁻²⁷ the crack propagates as soon as moisture reaches the interface – before it has a chance to absorb into the bulk adhesive and change the impedance. Over time, this absorption occurs and the impedance decreases, but the crack has arrested or is growing very slowly as it reaches the point of sustainable stress. For the PAA specimens, crack propagation is within the adhesive and the limiting factor governing crack propagation under these conditions and times is not the interface, but rather, the weakening of the adhesive due to moisture absorption. For the FM-73 adhesive, there is a distinct relationship between the low-frequency impedance (absorbed moisture) and crack growth until the crack arrests after approximately one centimeter of propagation. A similar relationship is likely for FM-300 adhesive, but the data are limited in this region. At the arrest point, the adhesive continues to absorb moisture, but without additional crack growth.
